REPORT
OF
THE COURT INVESTIGATING

ACCIDENT TO AIR INDIA
BOEING 747 AIRCRAFT VT-EFO,
"KANISHKA"
ON 23RD JUNE 1985

FEBRUARY 26, 1986

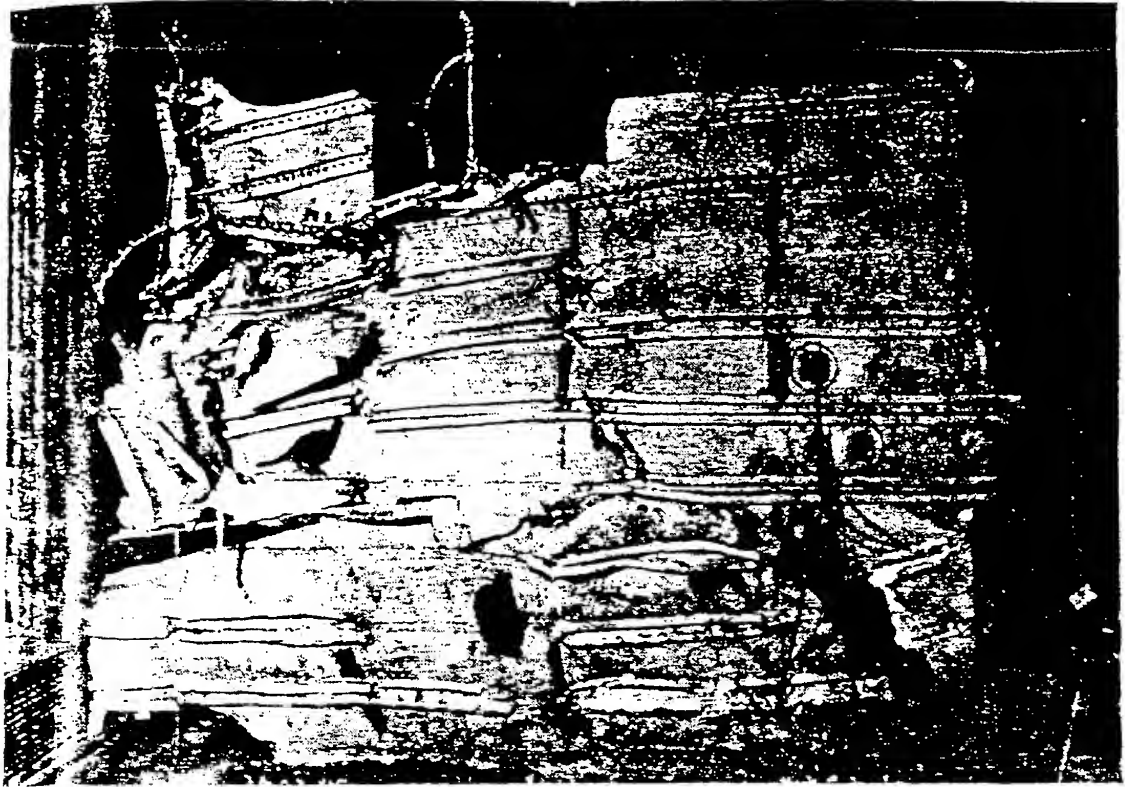
3.2.11.24 Much of the damage on this target was on the skin and stringers beneath the window level, i.e., on the starboard side of the front cargo hold. The inside and outside surface of the skin in this region are shown in Fig. 399-2 and 399-3 respectively. There were 12 holes or damaged areas on the skin as described above, generally with petals bending outwards. The curl on a flap around hole no.1 shown in Fig 399-4 has one full turn.

Fig. 399-2. Portion of target 399 below floor level, inside surface.

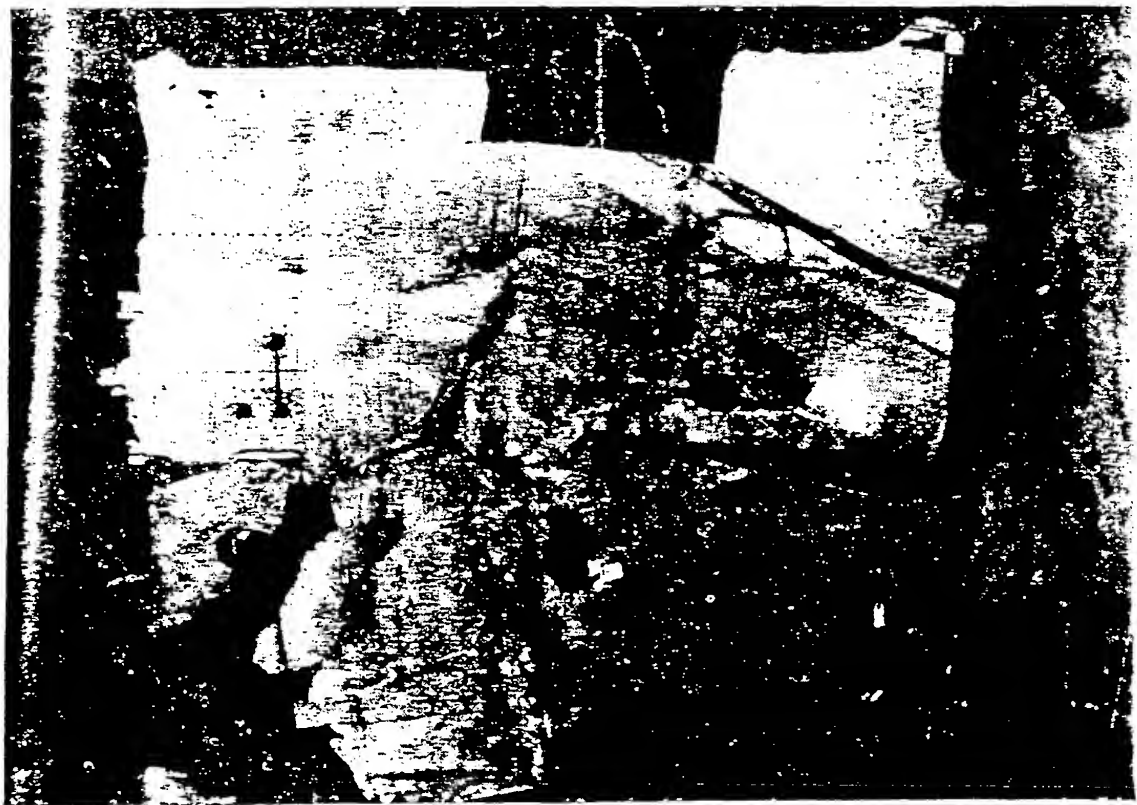
Fig. 399-3. Portion of target 399 below floor level, outside surface.

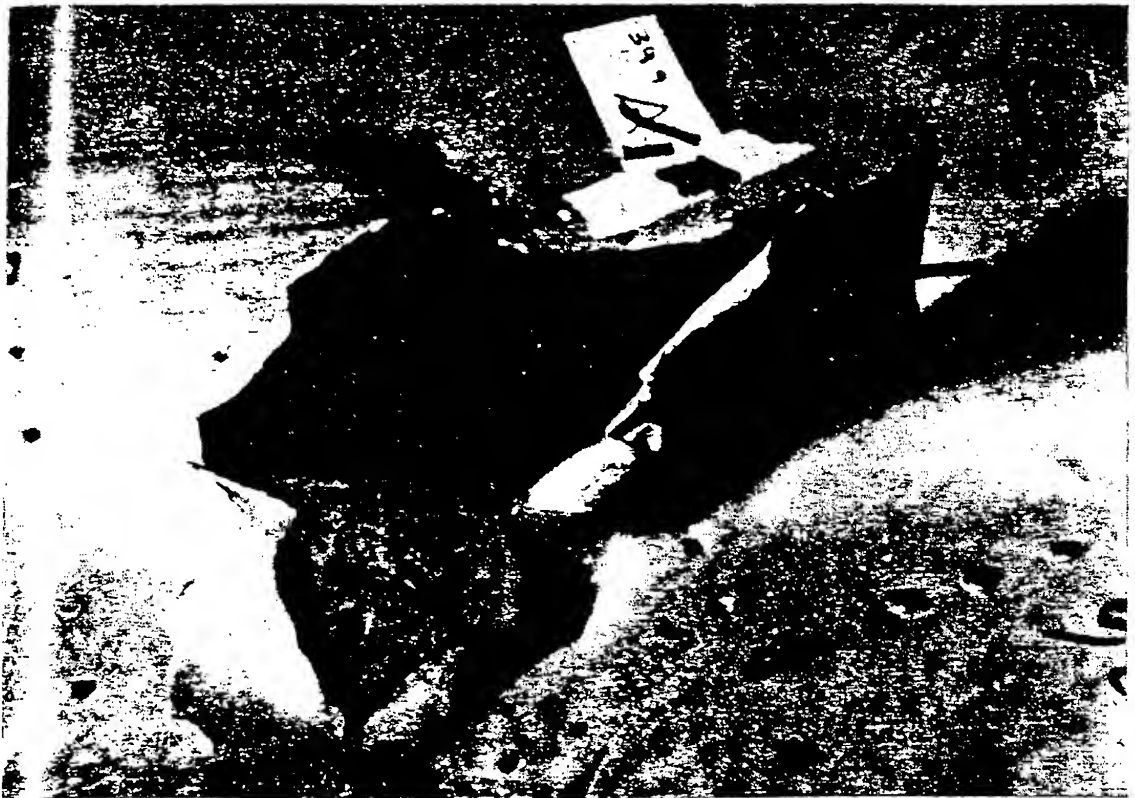
Fig. 399-4. Curl on a flap in hole no.1 of target 399.

This curl is in the outward direction. Cracks were also noticed around some of the holes. Part of the metal was missing in some of the holes. The edges of some of the petals showed reverse slant fracture. In one of the holes, spikes were noticed at the edge of a petal.

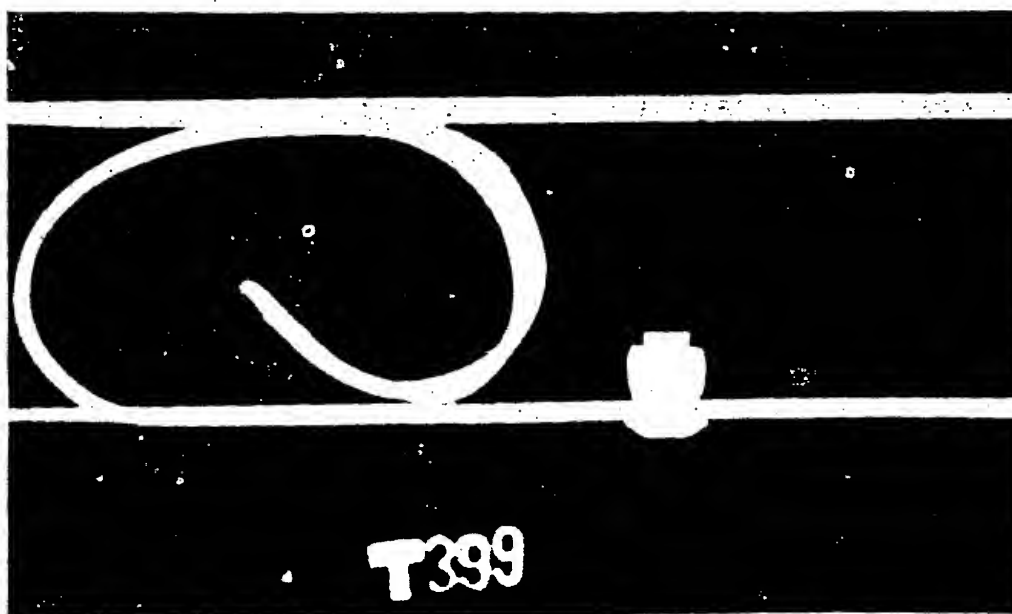
Fig. 399-6. Print from a radiograph of the stantion (Refer Fig.399-5) showing inward curling.

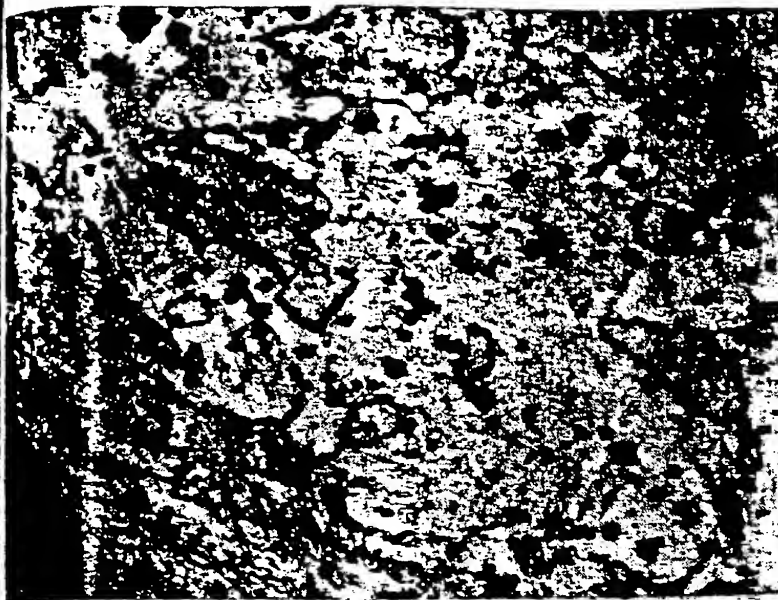
Fig. 399-7. Microstructure near the fracture edge of the station showing twins. 400X.

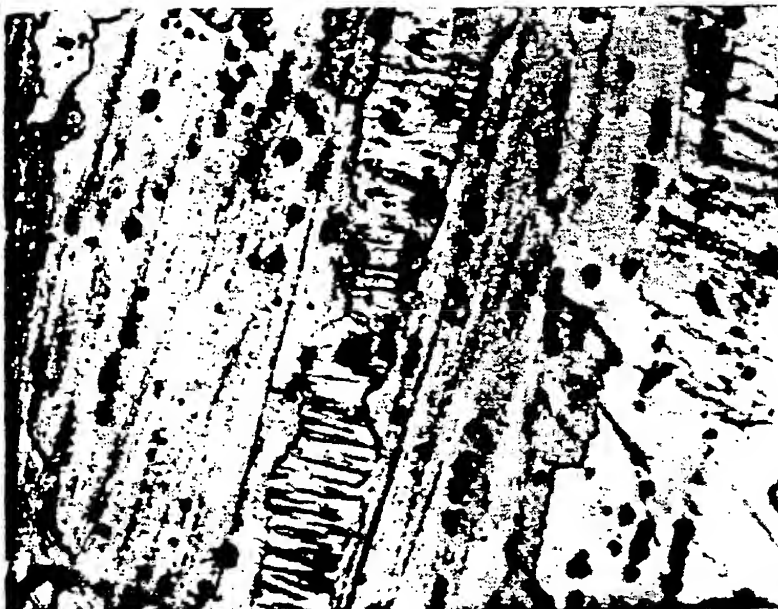
Fig. 399-8. Microstructure near the fracture edge of the station showing twins. 400X.

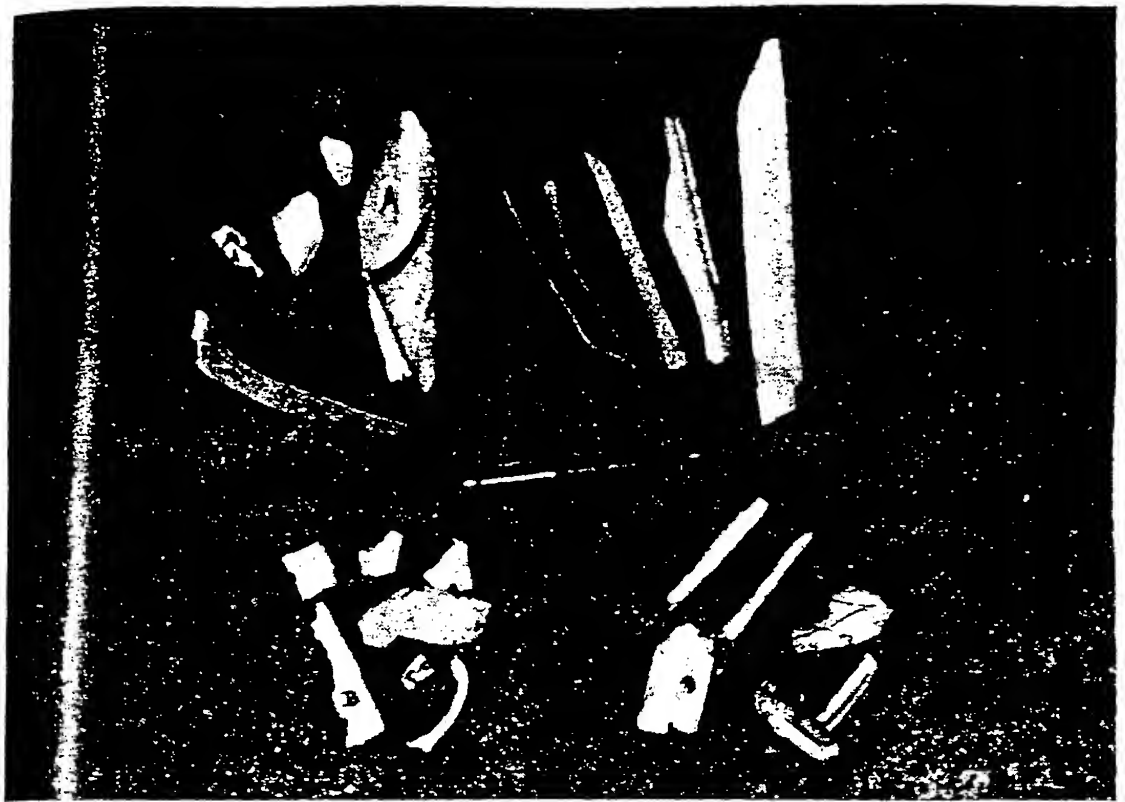
Fig. 399-10. A collection of small fragments recovered from target 399. A : Curved fragment. B : Fragment with reverse slant fracture. C : Spike fragment.

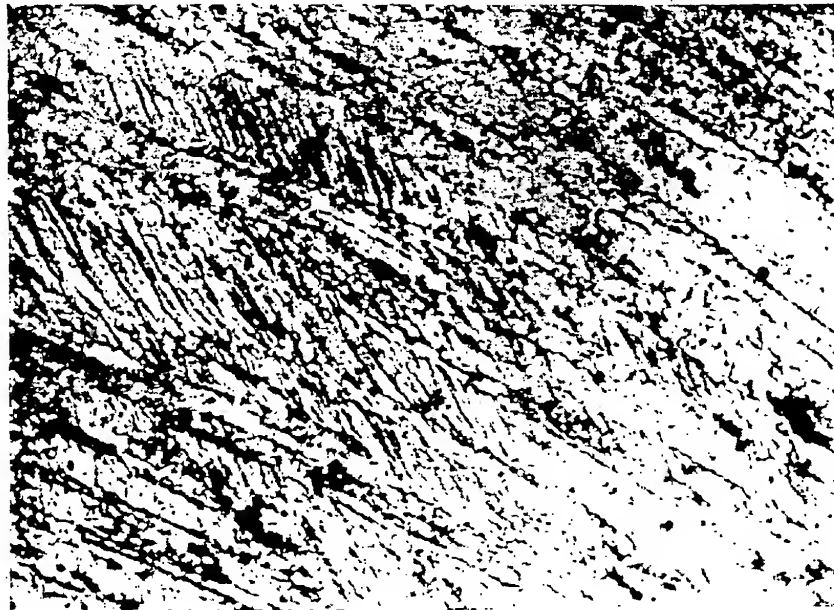
Fig. 399-11. Microstructure of the spike fragment (C in Fig. 399-10) showing twins. 320X.

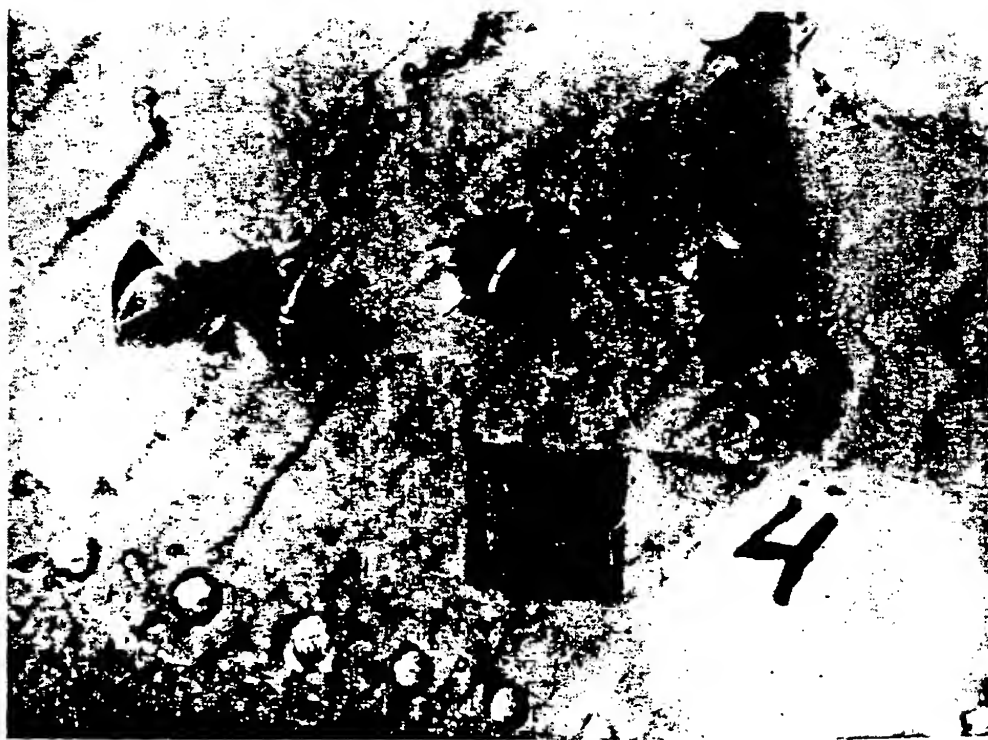
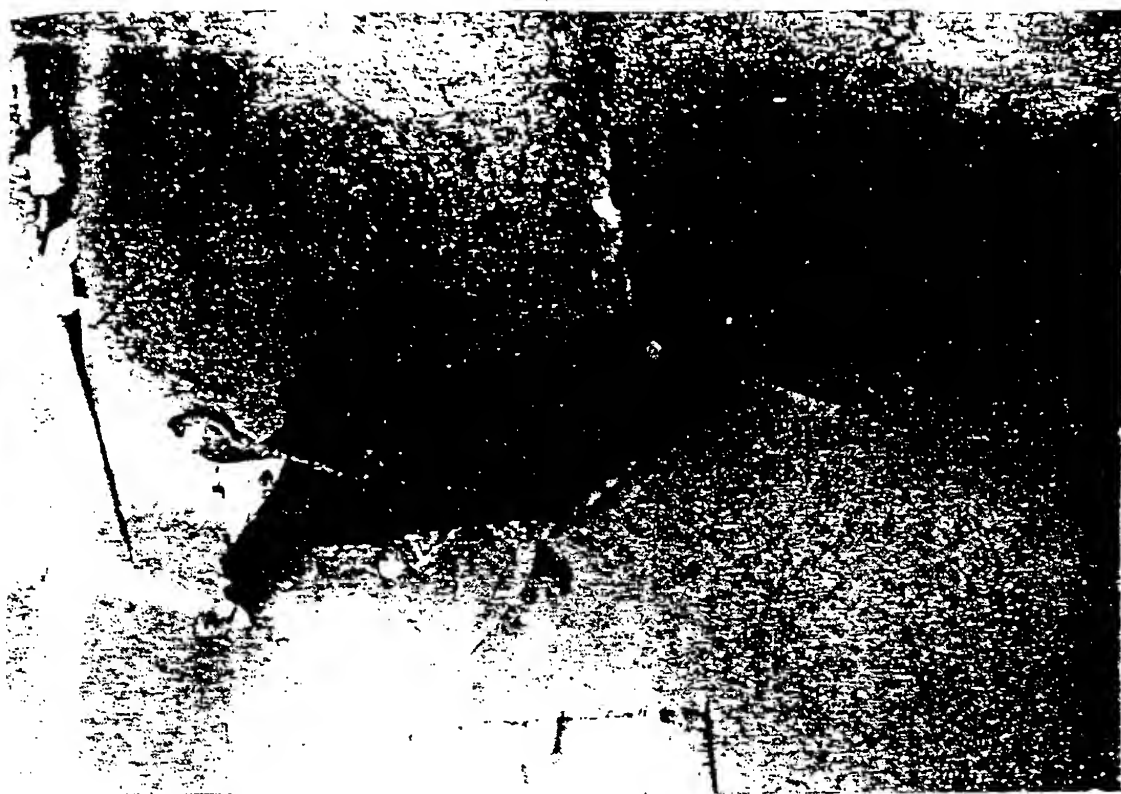
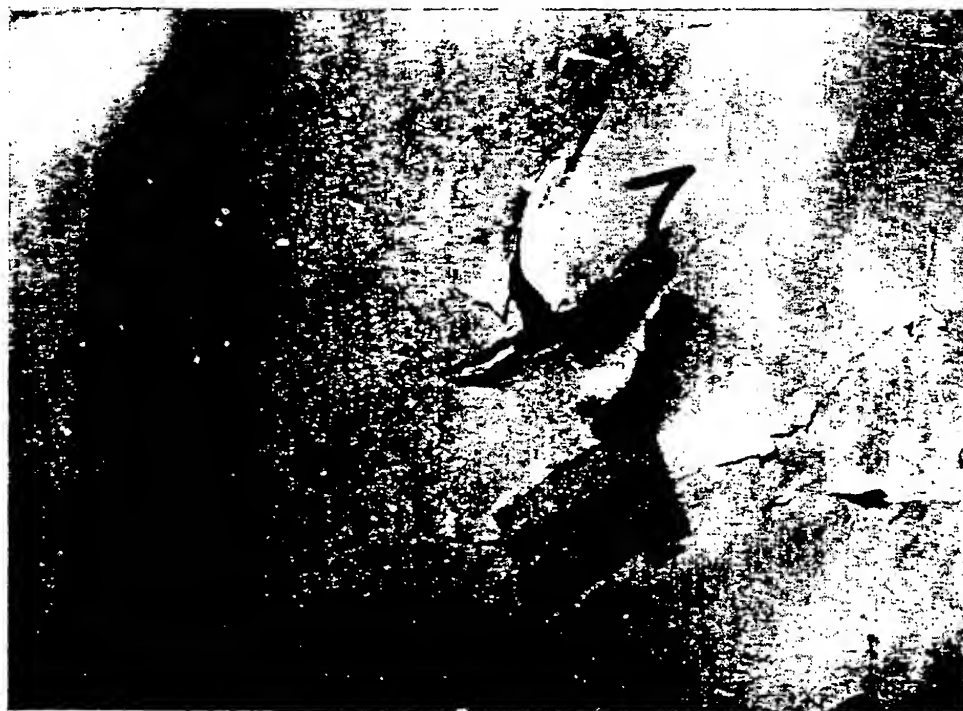
3.2.11.30 Fig. 362-3 to 362-7 show a few of these holes. There were also cracks or tears around some of the holes. The curls around some of the holes had nearly one full turn. In the large tear between body stations 700 and 740 and stringers between 41L and 45L, there were many pronounced curls as shown in Fig. 362-8. On the edges of the petals around

several holes, reverse slant fracture was seen at a number of places. This slant fracture is at an angle of about 45° to the skin surface, the fracture continuing in the same general direction but with the slope of the slant fracture reversing frequently.

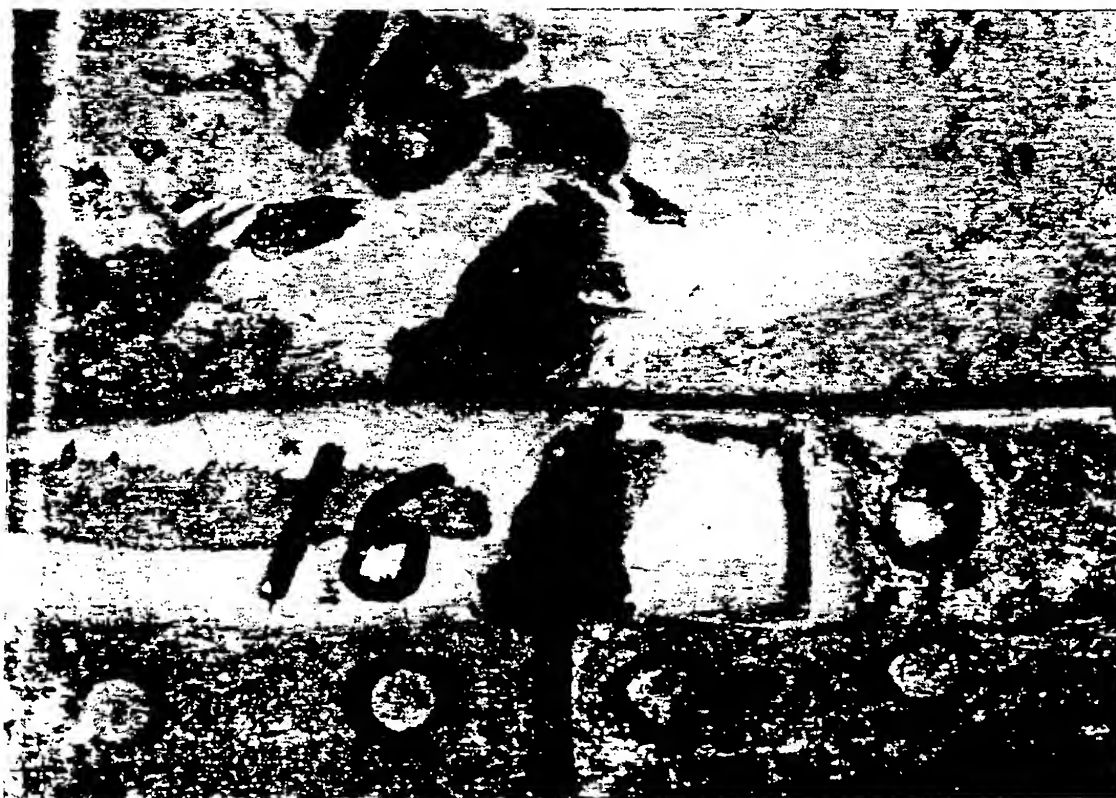
Fig. 362-14. Hole no.16 of target 362, through stringer 47L, inner side of skin.

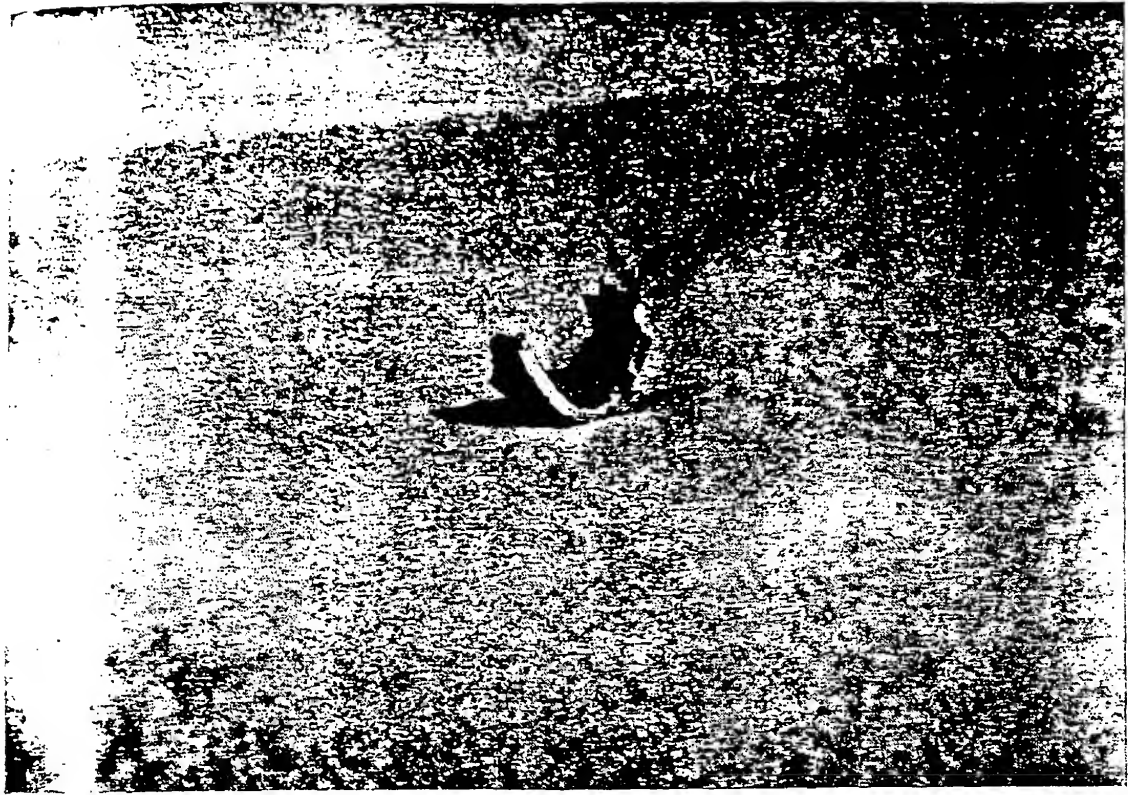
Fig. 362-15. Spikes at the edge of hole no.16, inside the stringer.

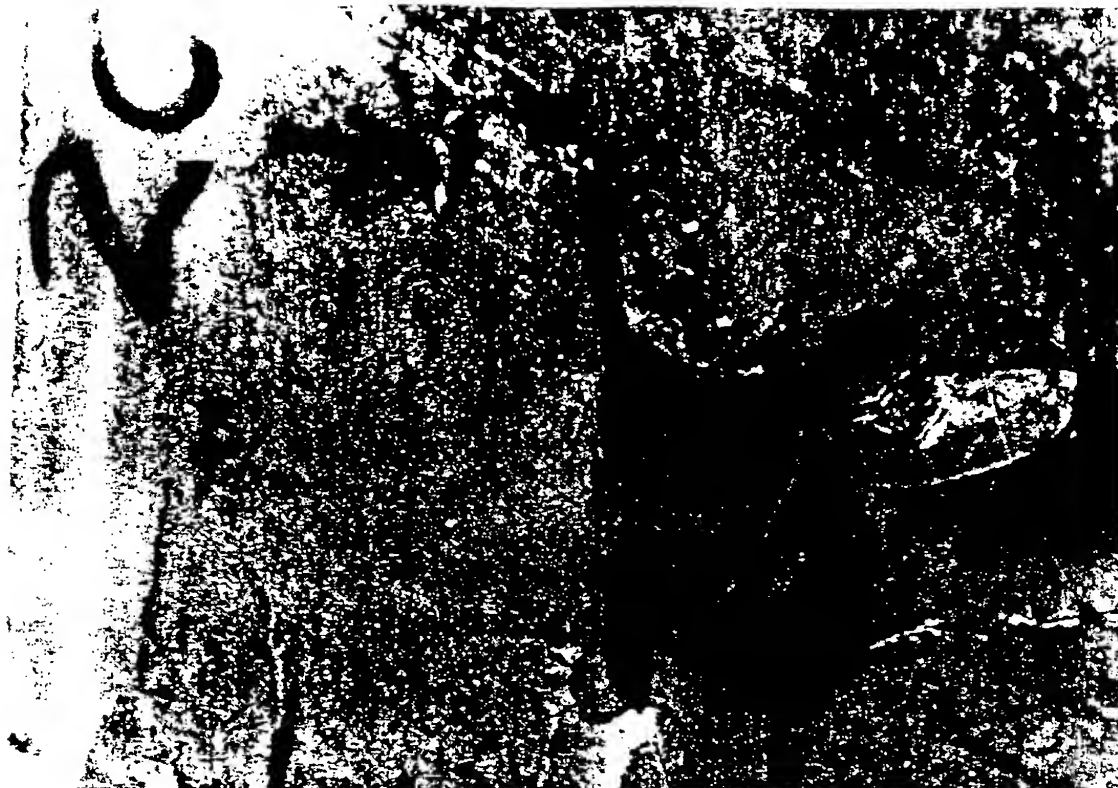
Fig. 362-19. Impact mark on a petal in hole no.20.

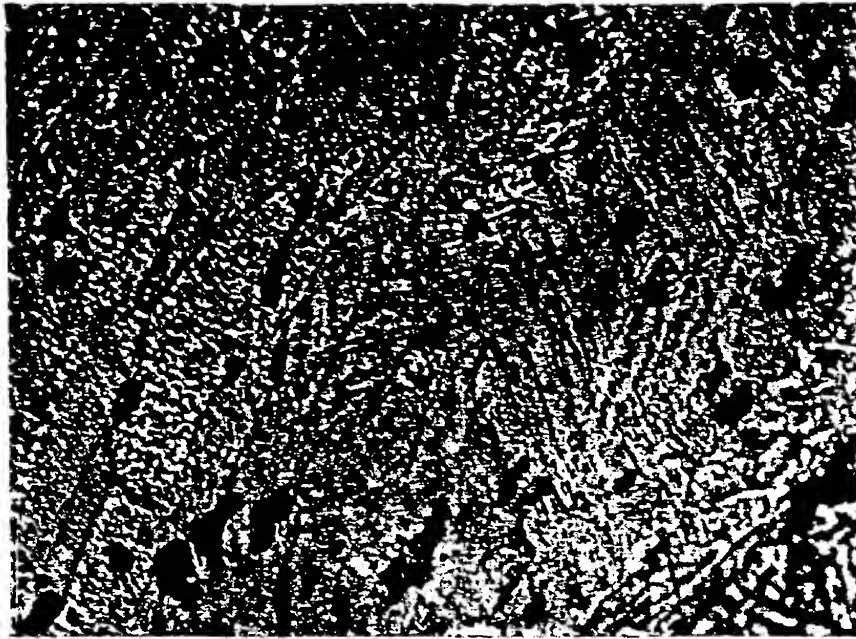
Fig. 362-26. Twin bands in the grains adjacent to hole no.14. Keller's etch. 750 X.

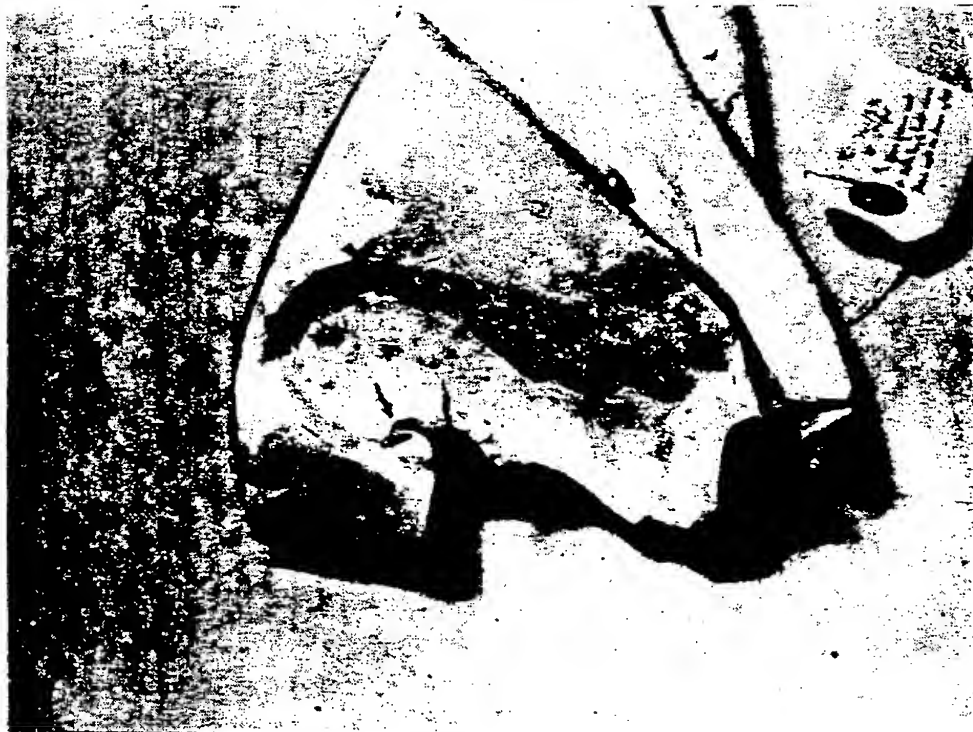
Fig. 362-27. Web of roller tray of target 362 showing curling (see arrow).

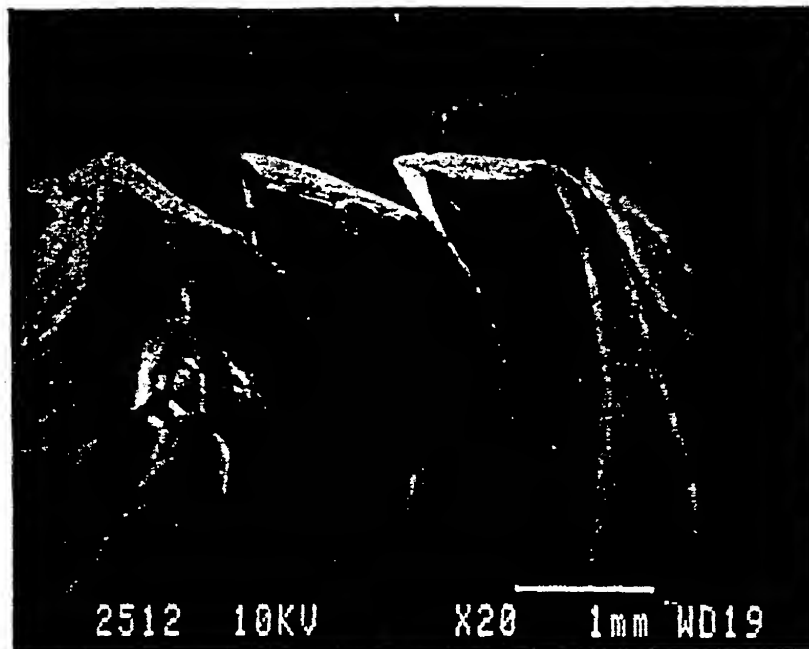
3.2.11.39 Another small fragment was found from the above target. This piece, identified as specimen No. 12 in box No. 1, target 362, has a number of spikes along the edge. A scanning electron micrograph of the spikes is shown in Fig. 362-28. The sides of the spikes on SEM examination revealed elongated dimples as shown in Fig. 362-29, characteristic of shear mode of fracture. Metallography was carried out on the thickness side of this specimen. Fig. 362-30 and 362-31 show the microstructure near the apex of the spike and at the root of the spike respectively. Extensive twinning can be seen in these regions of the spikes.

Fig. 362-28. SEM photograph showing spikes in a fragment from target 362.

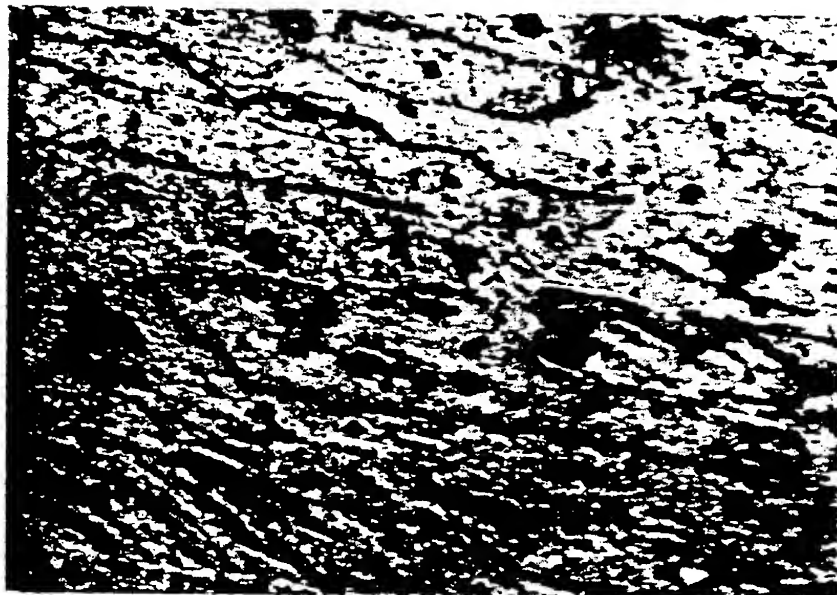
Fig. 362-30. Microstructure of the spiked fragment shown in fig. 362-28, near the apex of a spike, showing twins. 400 X.

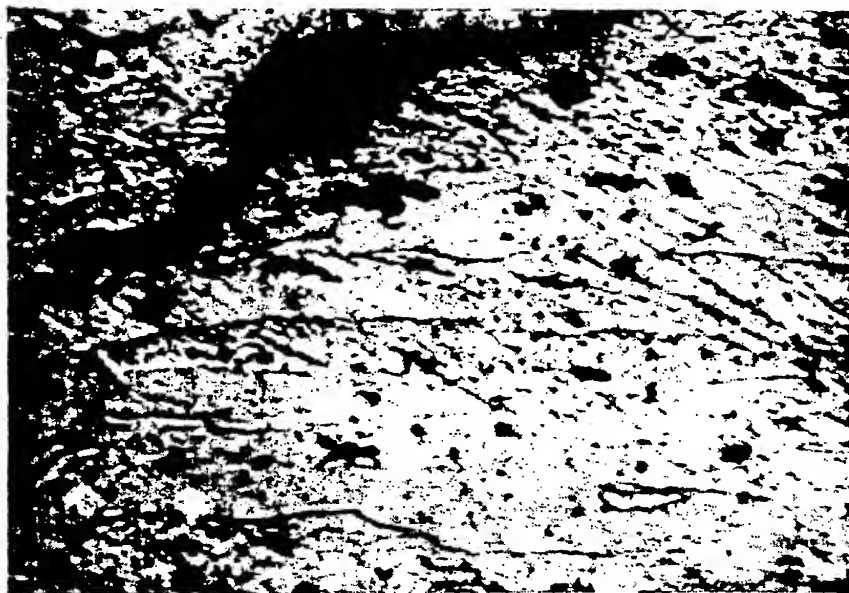
Fig. 362-31. Microstructure of the spiked fragment shown in Fig.362-28, near the root of the spike, showing twins. 400 X.

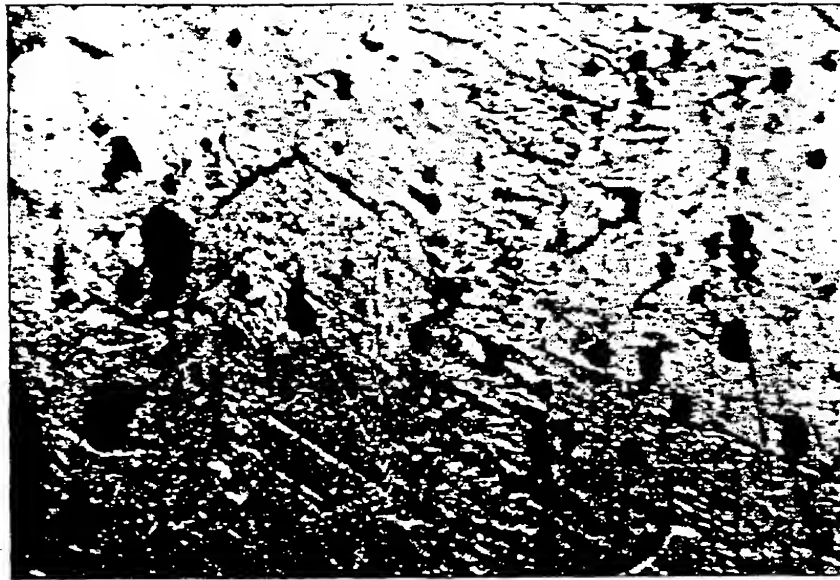
3.2.11.40 Another fragment recovered with target 362 and identified as specimen No. 8 in box No. 1, also showed extensive twinning. The microstructure is recorded in Fig. 362-32.

Fig. 362-32. Microstructure of a fragment from target 362 (specimen No.8, box No.1) showing twins. 500X.

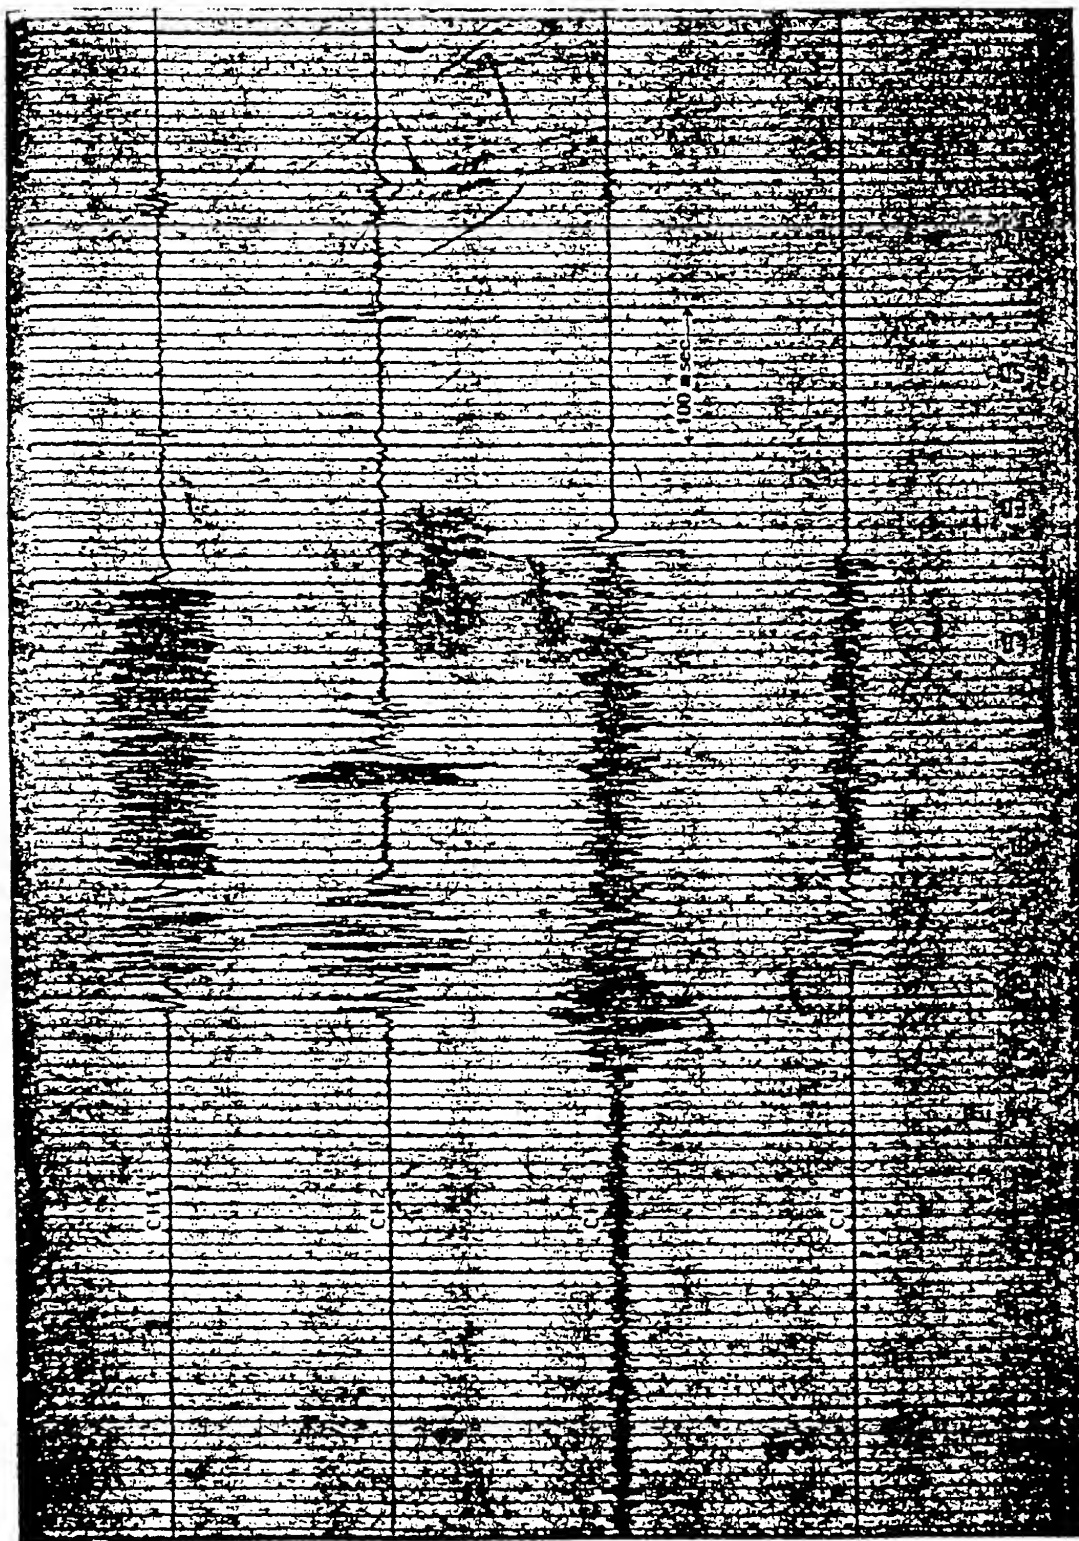
"The first visible rising signal volume was observed on channel number three the CAM channel. It reaches a maximum in about 50 milliseconds. At this time noticeable disturbances are observable on the other three channels. A smaller disturbance is observable on channels 2 and 4 earlier than observable on channel 1. A major disturbance is observed to begin approx. ninety milliseconds following the initial observation on channel number 3 (CAM), on channels 1,2 and 4. Following this point

Fig. 1 : KANISHKA -- UV recording of CVR Channels.

at 75 milliseconds the CAM signal subsides to a lower level but much higher than observed ambient (prior to disturbance) where it remains for approximately 375 milliseconds from initiation when it ceases. Channel four goes off at the same time. Channel 1 goes off twenty five milliseconds earlier. Channel two is inconclusive and had a different pattern. All four channels exhibit a disturbance at approx. 450 milliseconds. The cockpit voice recorder power then shuts off at 650 milliseconds.

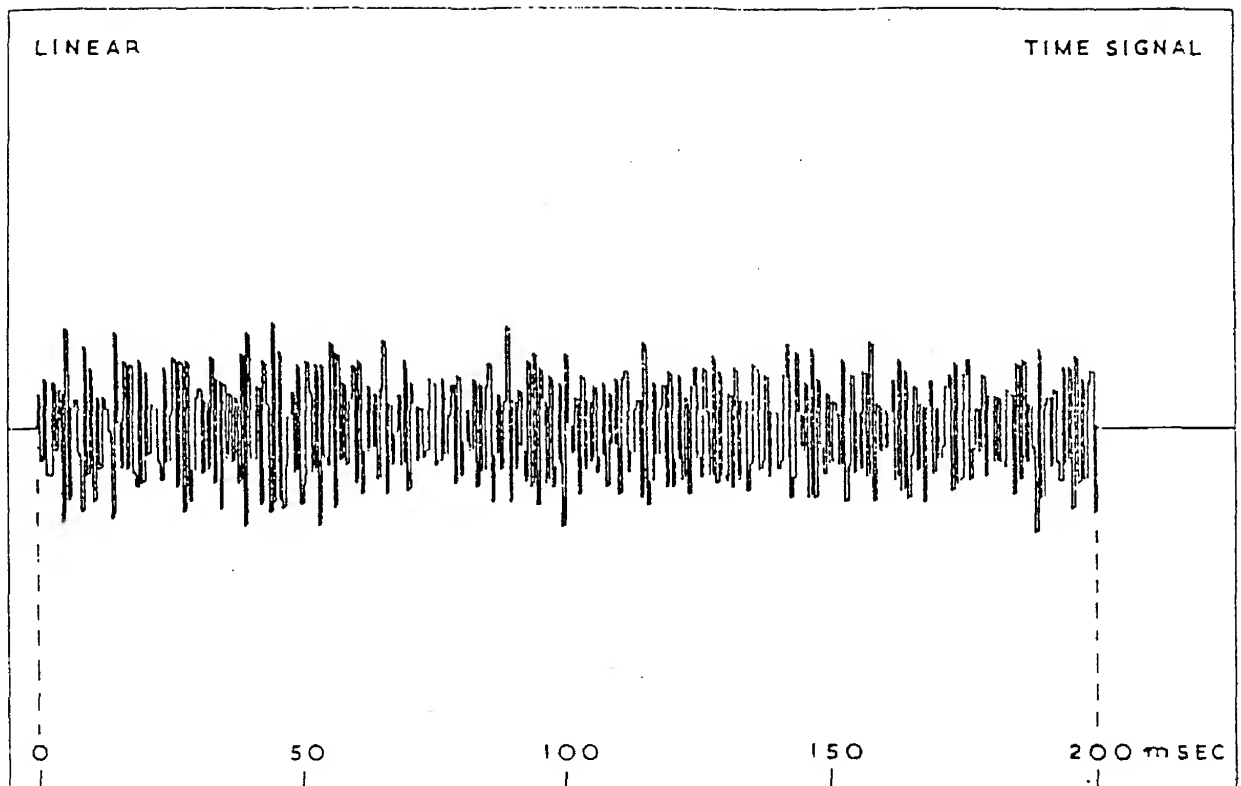
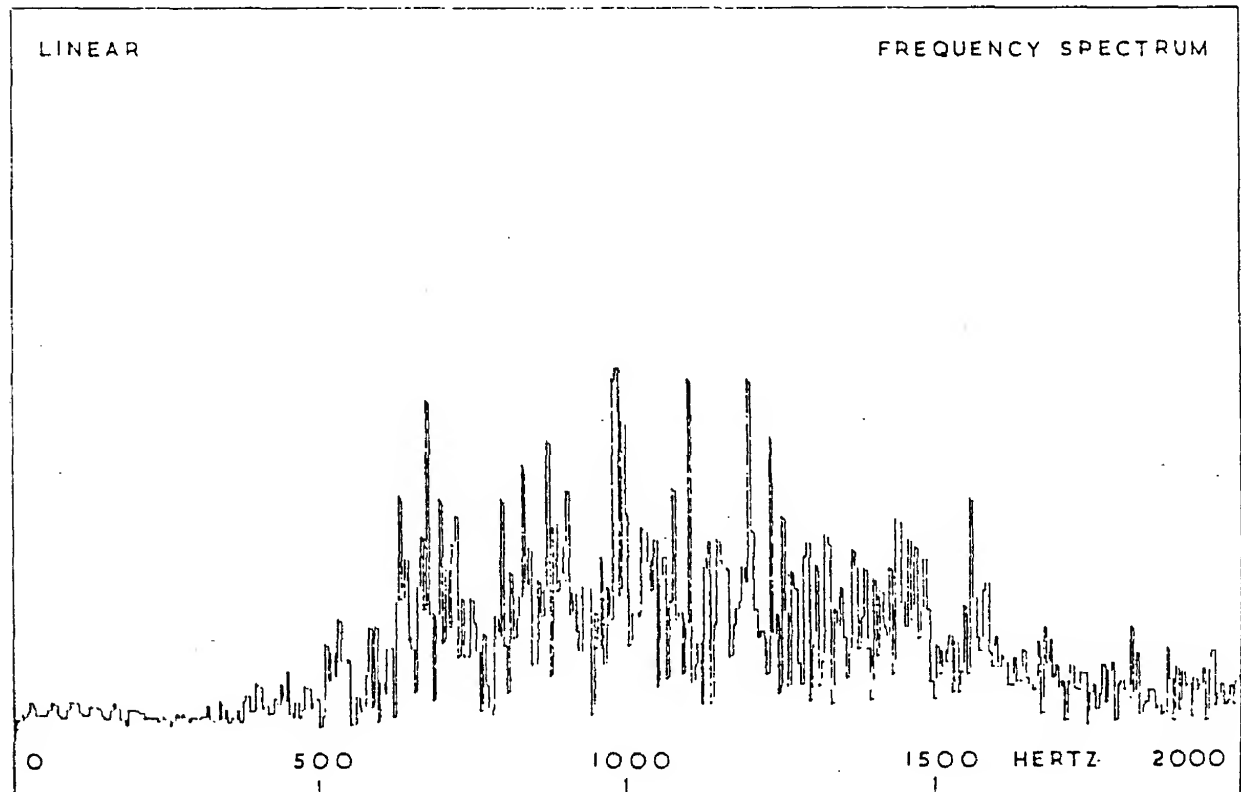
CHANNEL 3: JUST BEFORE BANG

Fig. 2 : KANISHKA — Time Signal and Frequency Spectrum of CAM Channel just before 'bang'.

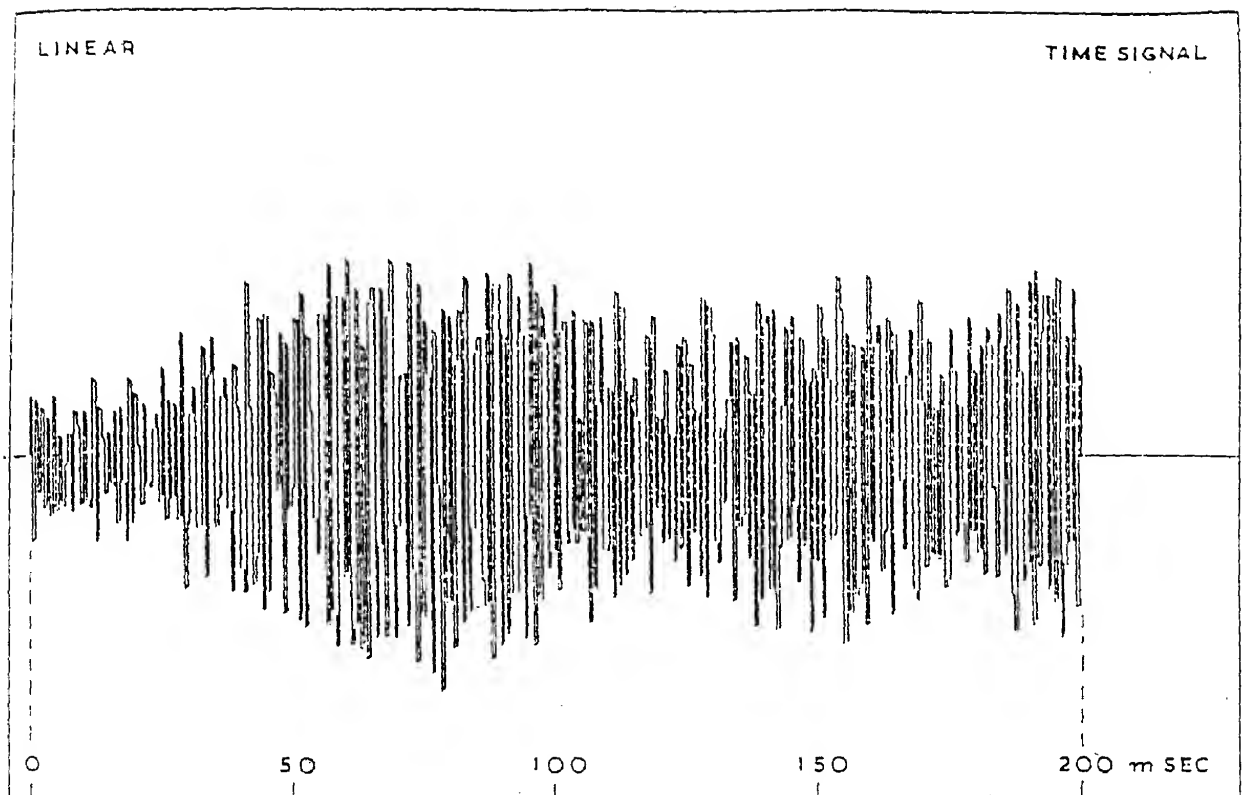
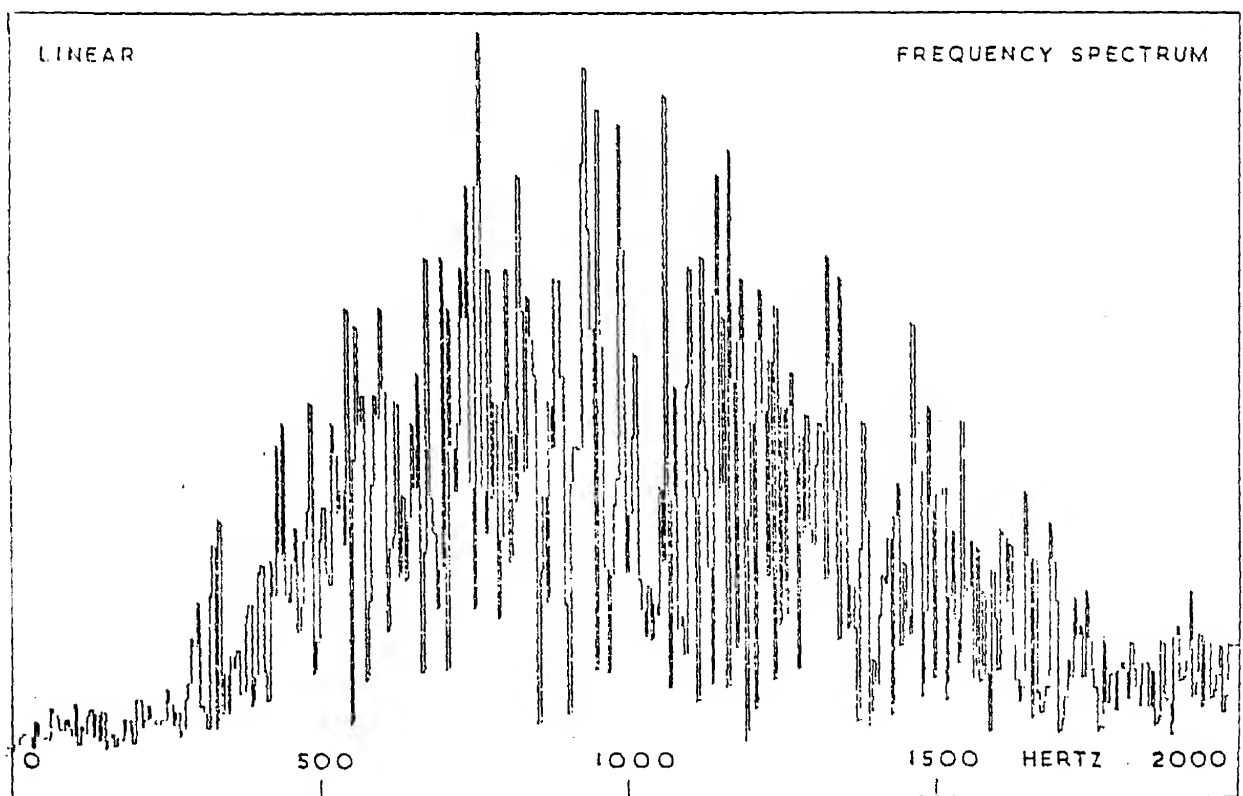
CHANNEL 3: AT BANG

Fig. 3 : KANISHKA — Time Signal and Frequency Spectrum of CAM Channel at 'bang'.
